November 9, 2017

**Re: Grand Rapids IRA Civic Center – West Venue Roof – Truss Web Failure  
NCE Job No. 17-665**

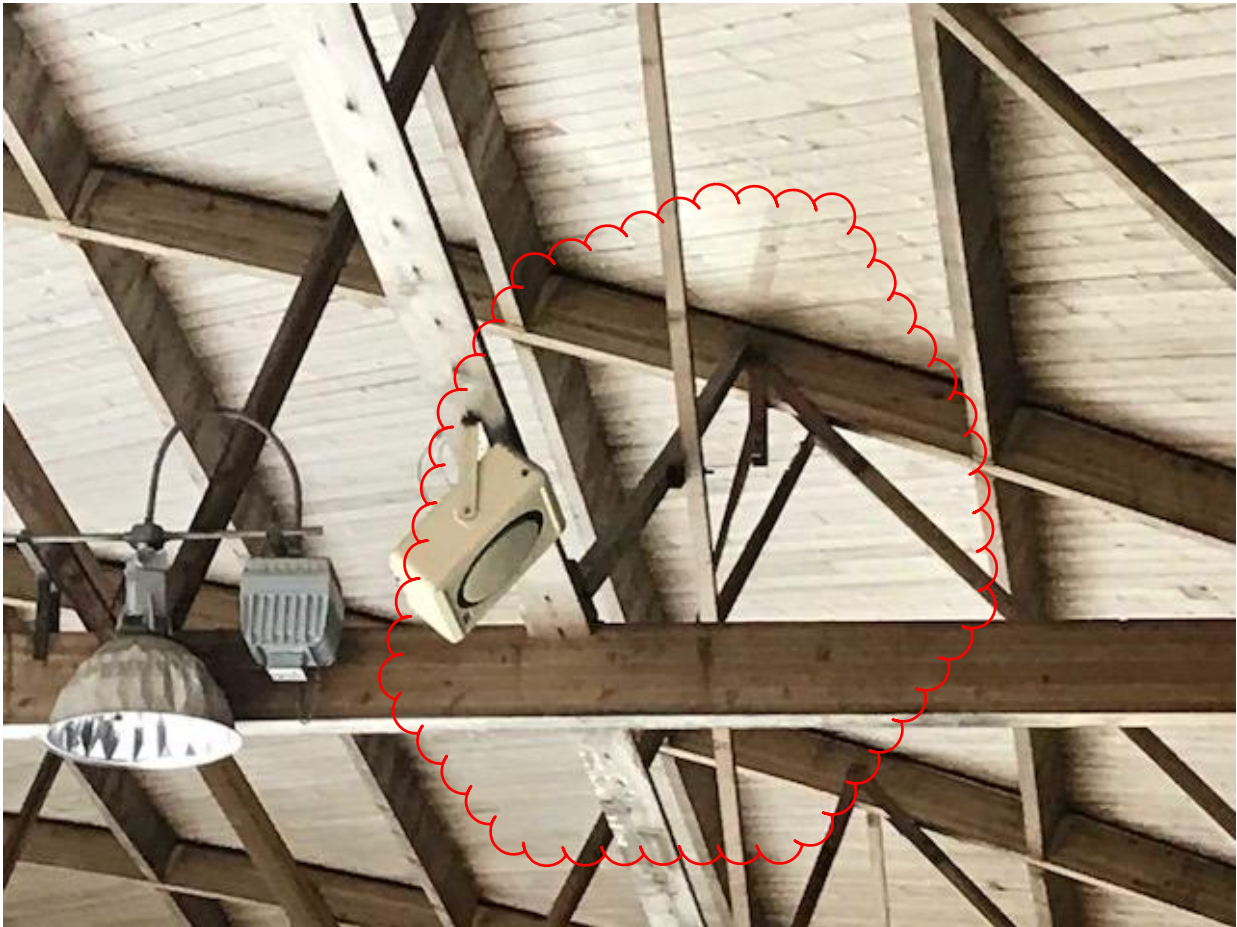
When we arrived, we walked the east bleachers and discovered a failed member of the 5<sup>th</sup> truss from the north end of the building. Based on our analysis, the failed member is one of the members most effected by an unbalanced loading condition.

After the meeting, we observed the roof snow loading from the adjacent roof and noted that only a few inches of snow appeared to be on the roof. We also observed the truss again and noted that the adjacent web members were bowed significantly and appear to be in danger of failure. We directed the Manager to close the West Venue and to shore the truss.

2. Since very light snow loading appears to have caused this failure and the failure appears to have nearly caused the collapse of a roof truss that could have endangered the entire facility and the occupants, it is our professional opinion that some long-term deterioration of the wood capacity has occurred. Based on our discussions with NRR1 this morning, this deterioration can be due to long term alternating wet and dry environments that can affect the fiber strength of the material.

We directed the manager to get the truss shored up immediately and to get the truss member replaced.

1. Shoring: The top and bottom chord of the truss should be supported from the ground surface until the repair is made. It is not sufficient to shore only the bottom chord.
