**IRA CIVIC CENTER**

**GRAND RAPIDS, MINNESOTA**

Your Client: City of Grand Rapids  
Claim No.: CP44375  
Date of Loss: November 13, 2017

Crane File No.: 91632  
Crane Descriptor: CITY OF GRAND RAPIDS –  
LEAGUE OF MN CITIES – CIVIC CENTER

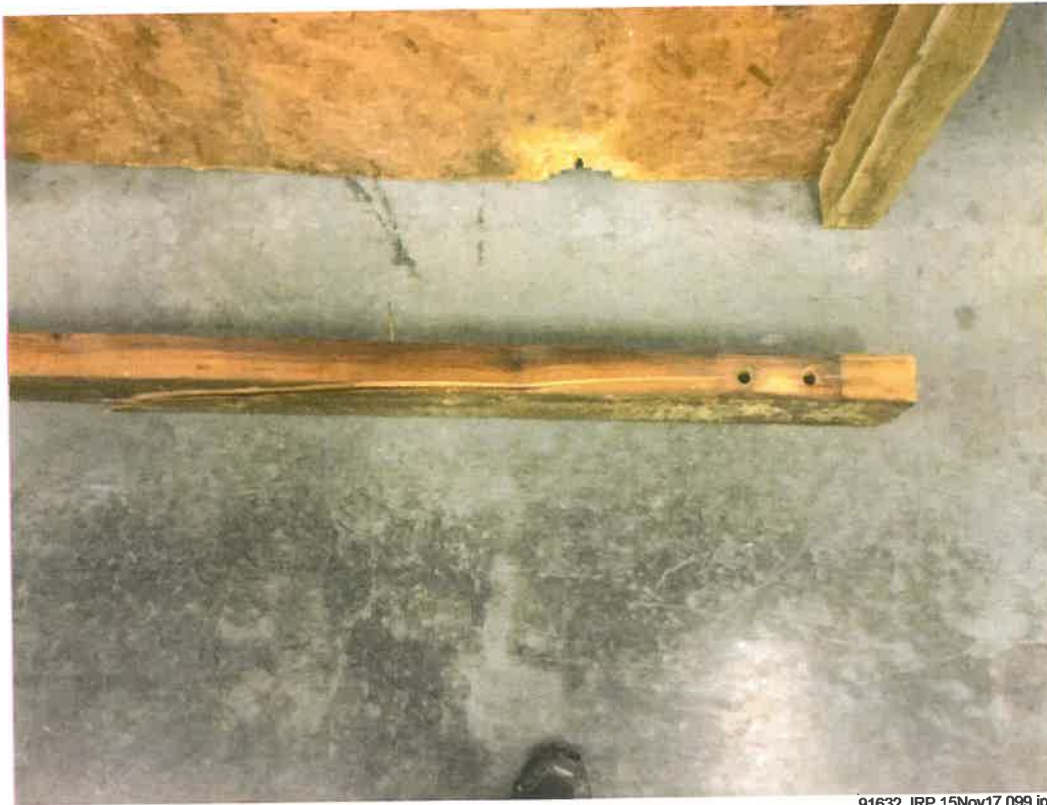
91632 JRP 15Nov17 099.jpg

Crane Engineering performed a site inspection of the IRA Civic Center roof structure on November 15, 2017. The inspection included visual observations made from floor level and from a scissors lift. Measurements of the truss were taken using a pocket tape and a Hilti digital range meter. At the time of this inspection, the failed web member had been removed and temporarily replaced. The failed web member was retained on site and was visually observed by Crane Engineering. The failed web member measured 2 ½ inches deep by 5 ¼ inches wide. Two ¾ inch diameter holes were drilled through the width of the member at the top and bottom where through bolts were used to connect the web to the chord members of the bowstring truss. A crack was observed through the width of the member that appeared to originate at the bolt holes at the top of the member. Refer to Figure 1.

Figure 1. Crack in 3<sup>rd</sup> web member from east wall of fifth truss from the north end.

The failed web member is likely due to an accumulation of unbalanced snow along the east side of the truss that caused the slender web member to become overstressed in compression, resulting in a failure at the upper connection. It is likely that the subject web member partially fractured from a snow event that occurred in a previous season, significantly weakening the member. This caused the subject web member to completely fail during the recent snow event in November of 2017, under relatively light snow loading conditions.

1. The as-built condition of the roof structure for the original 1962 west venue appears to be under designed to support the unbalanced snow loading conditions that are occurring on the surface of the roof.
2. The truss web member failed as a result of a load reversal from tension stresses to compression stresses caused by an unbalanced snow load condition along the east side of the subject roof.

To restore the structure back to a comparable condition prior to the loss, the failed web member can be replaced with a new member that is properly sized to meet the loading requirements of the current building code. During this process, the subject truss will need to be properly shored up at both the top and bottom chords. The remaining roof system of the subject building should be evaluated by a structural engineer to determine how to retrofit the structure to bring it to a safe working condition.

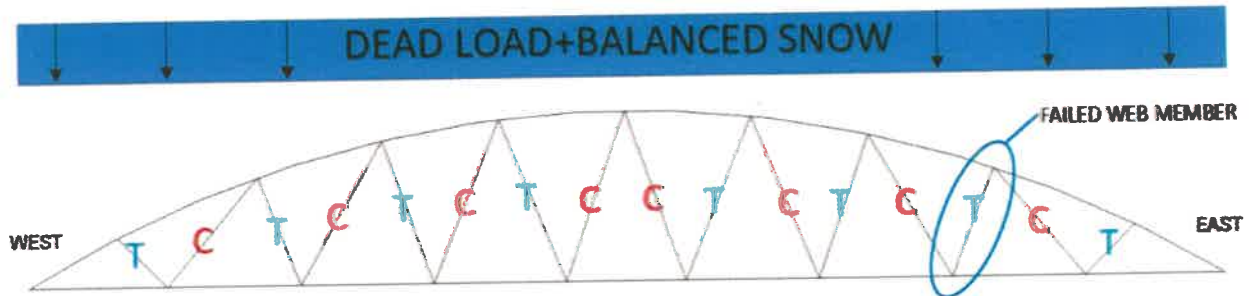
Under the dead load + balanced 30psf snow load condition, adjacent web members of the truss alternate between tension and compression members with the first, third and fifth web member in from the exterior wall as tension members and the second, fourth and sixth web members in from the exterior wall as compression members. Figure 2 shows the location of the tension and compression web members marked with a T or C respectively, when a uniform snow load is applied. The analysis under this loading condition shows the roof trusses are not capable of safely supporting the weight of a uniform 30psf snow load.

Figure 2. Tension and compression diagram of web members with balanced snow loading.

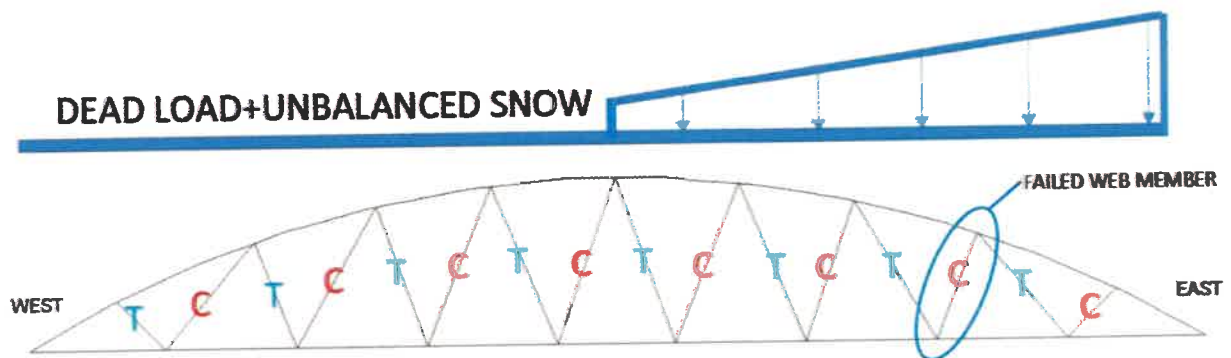
Under the dead load + unbalanced snow load condition applied to the east side of the truss using the methods prescribed in Chapter seven of the ASCE 7-10 with a 30psf snow load, the web members on the east side of the truss that were in tension under the balanced snow load condition switched to compression members. Figure 3 shows the location of the tension and compression web members, marked with a T or C respectively when the unbalanced snow load condition is applied to the truss.

Figure 2. Tension and compression diagram of web members with unbalanced snow loading.

The analysis shows that a load reversal occurs in the web members of the subject truss when an unbalanced snow load is present along the east side of the truss. This causes slender web members that were originally designed as tension members to become compression members. The subject web member was 2 ½ inches deep by 5 ¼ inches wide, making it susceptible to out-of-plane bowing in the narrow direction under compressive stresses.
